Re: NJDOT FY23 Grant Ideas for Transit Village Area

Results of the WWBPA's survey of the area around the Princeton Junction Railway Station.

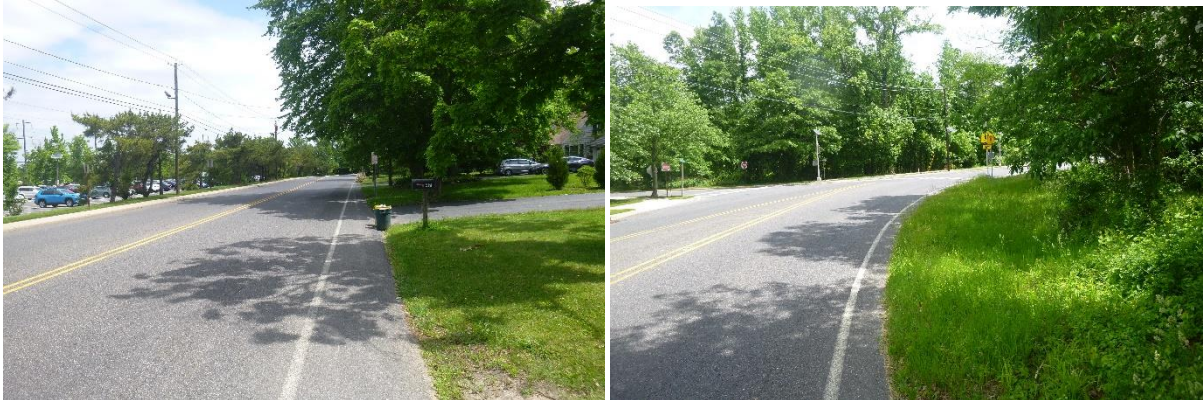
a) Alexander & Scott – Residential side.

The existing shoulder in this section narrows from ~32" to ~16". There is no true bike lane.

Recommendation: Reduce the lane width to 10ft and add bike lane in both directions from Alexander to Scott where the current bike lanes begin/end. The reduced width will also encourage adherence to the 25mph speed limit.

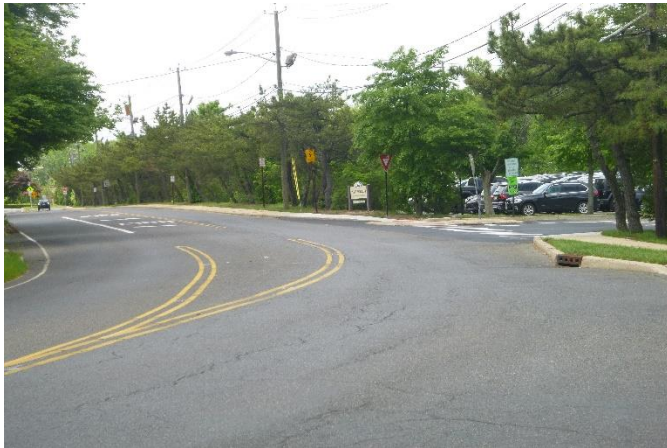
b) Alexander & Scott – Station side

There are no bike lanes nor shoulder.

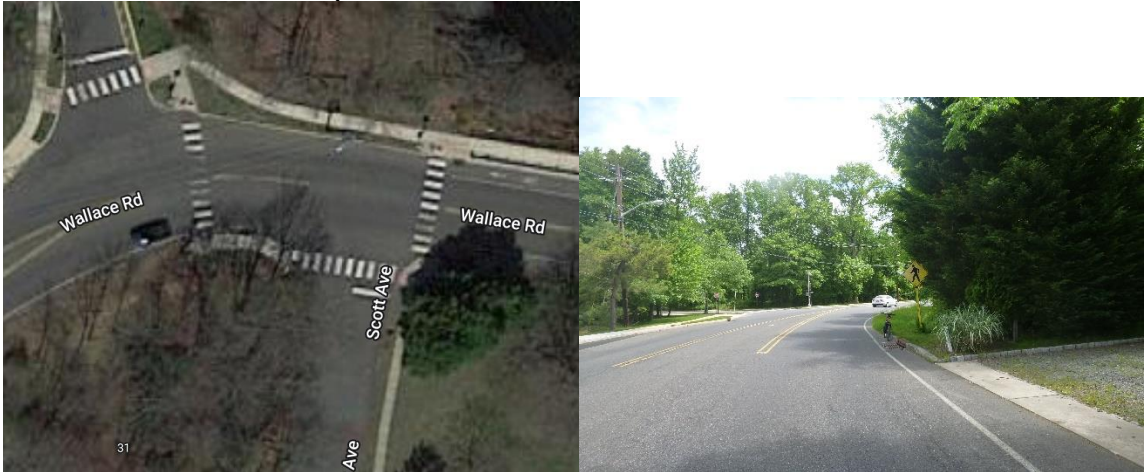
2. Pedestrian crossing at Scott traversing Wallace

Due to the curve of the road the flashing beacon on the residential side is easily obscured by trees only becoming visible when drivers are less than 120 ft away.

Also the "Share the Road" is hidden by tree branches

Recommendation: Make lights more visible – perhaps by having flashing beacons facing in both directions on both sides

Recommendation: Trim the trees blocking the "Share the Road" sign, just past Scott towards 571.

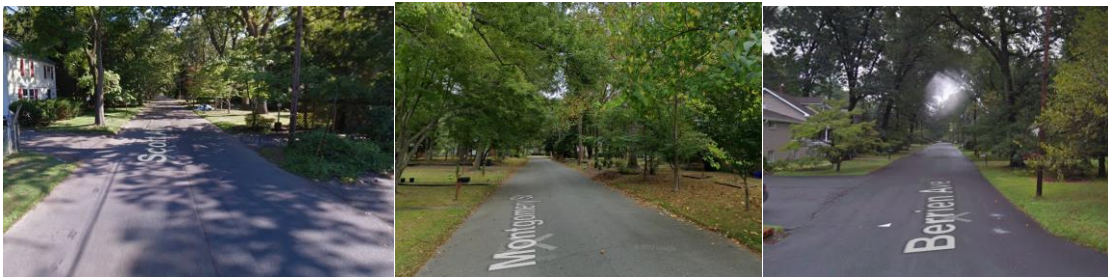
3. Berrien City.

In Berrien City between Alexander Rd and Clarksville Rd there are several streets that do not have sidewalks. The three pictured above – Berrien Ave., Scott Ave., and Montgomery St. – are all adjacent to the Maurice Hawk school and thus are prime routes for pupils walking to that school. In addition to elementary school pupils these roads are used by high-schoolers going to HSS and commuters to the station.

Recommendation: add sidewalks to these streets. It improves the safety for all users.

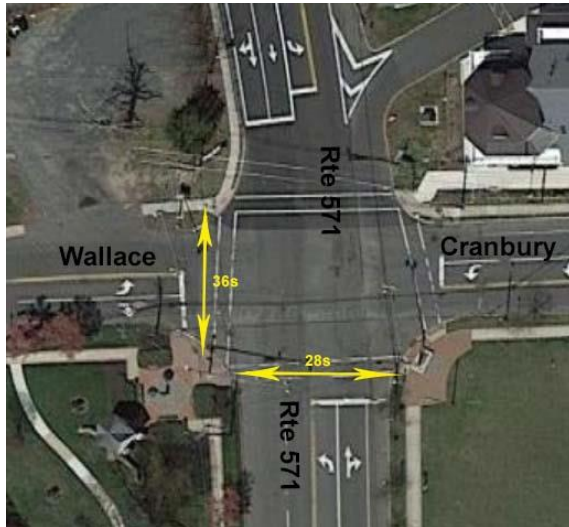
4. Intersection of 571 with Wallace & Cranbury Rds.

The pedestrian signal to cross 571 is not automatic and allows only 28 seconds. By contrast, the pedestrian signal to cross Wallace is automatic and allows 35 seconds to traverse a shorter distance.

Faulty? Fix the pedestrian signal viewed when crossing from PNC Bank to Walgreens, (i.e. the one on Walgreen's side), because the countdown timer isn't working.

Recommendation: Lengthen the time to cross 571, make the pedestrian signal automatic as it is on the Wallace and Cranbury crossings, and also add a pedestrian refuge. In addition making the right most lane off the railway bridge, "Right Turn" only – Rt571 becomes a single lane shortly after this junction. This would then allow for adding a "bump out" on the PNC bank corner, with the effect of making a much safer pedestrian crossing from that corner to the Walgreens side, as it would serve to remind right turning motorists of possible pedestrians crossing

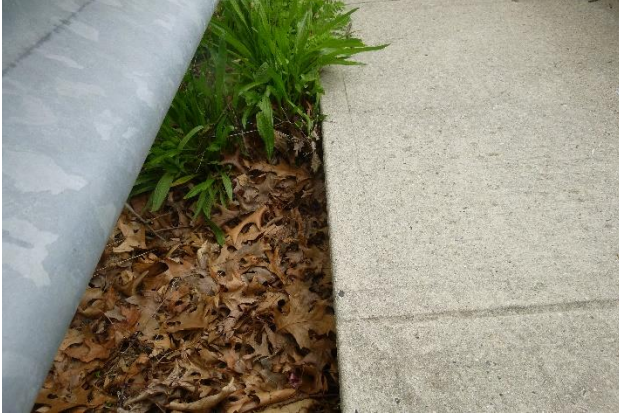
5. Pedestrian path across the 571 bridge

Approx. 125 ft. from the traffic lights, there is what looks like a washout that has created a steep fall away into the WW-P Transportation yard.

It becomes a danger if someone stands to that side to allow others to pass.

Recommendation: some remediation

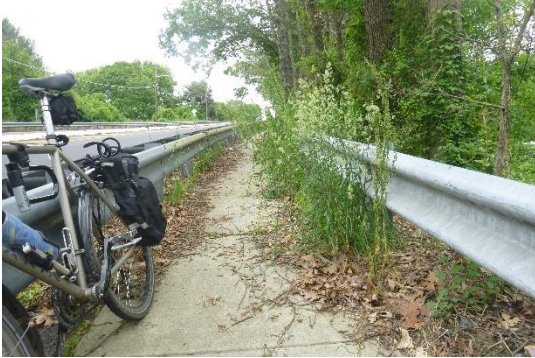
Further along this path there is significant incursion of foliage

Recommendation: Trimming it back

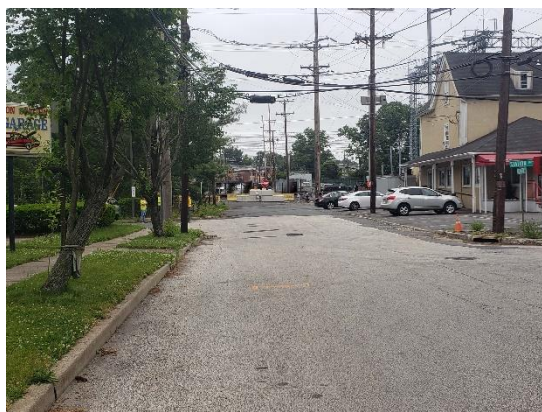
6. At Station Drive, behind the Asian Bistro & Princeton Garage

Free access to the train tracks.

Although it looks like additional, albeit temporary, barriers have been added since the “Car on track” incident of November 2019; access to the rail tracks is still easy. The metal fencing (the rear of WW-P Transportation yard) gives an optical illusion that it is in front of the track and not behind.

Recommendation: Additional signage is needed perhaps on the road surface (e.g. Stop), or lights on the barriers.

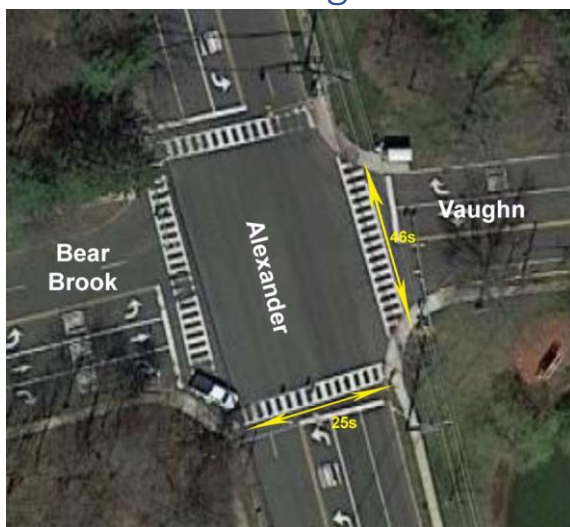
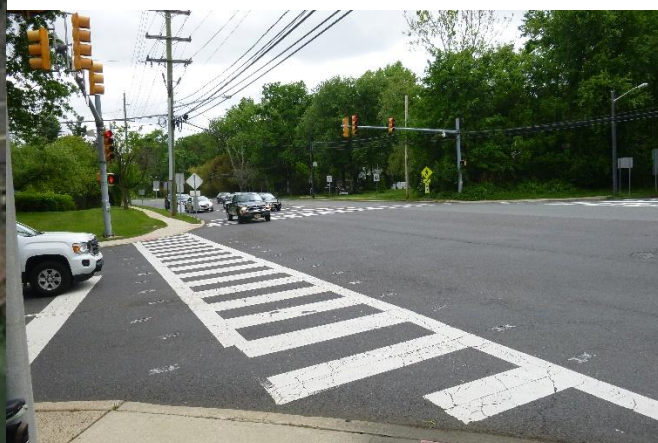
7. Alexander & Vaughn Dr.

The pedestrian signal to cross Alexander is not automatic and allows only 25 seconds. By contrast, the pedestrian signal to cross Vaughn is automatic and allows 46 seconds to traverse a shorter distance.

Faulty? Fix the countdown timer on the pedestrian signal near the dental office on Alexander; the timer vanishes at 16-17 seconds.

Recommendation: Lengthen the time and add a pedestrian refuge to cross Alexander. Change the signal from manual to automatic.
